UNITY HOME INSPECTIONS

UNITY HOME INSPECTIONS FULL HOME REPORT

Work Description: New Single Family Home

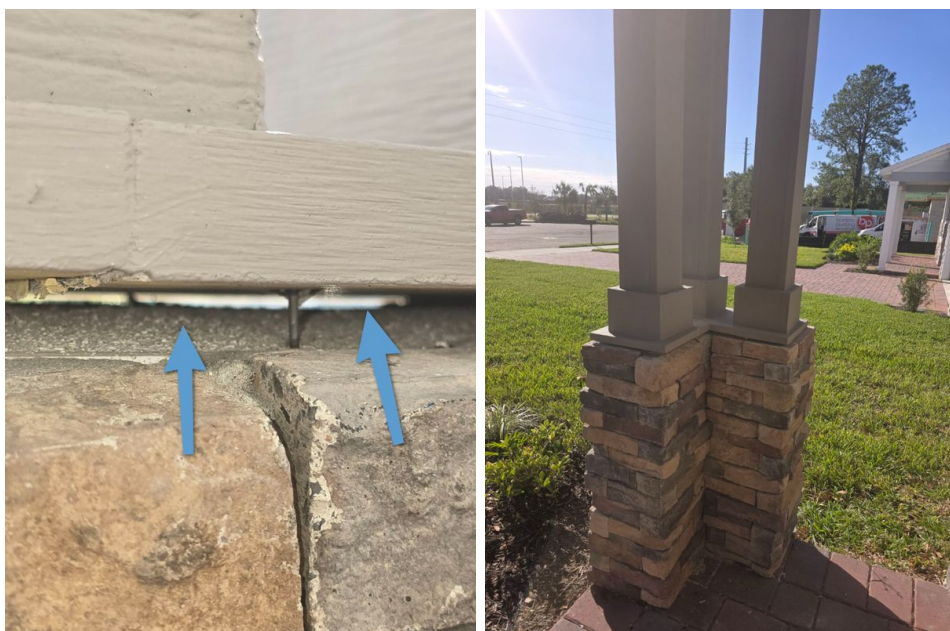
2.4.1 Walkways, Patios & Driveways

WOOD COLUMNS DO NOT HAVE FULL BEARING RESTING ON THE POURED INTERIOR. STONE PEDESTAL.

Recommend a qualified contractor evaluate and repair as needed.

Contact a qualified general contractor.

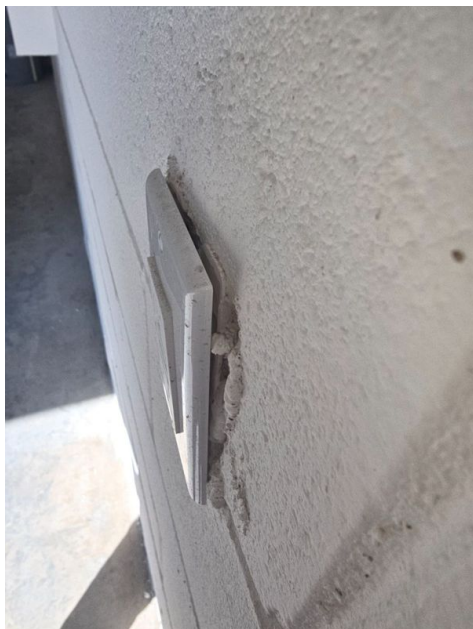
4.9.1 Garage Electrical

RECEPTACLE WIRING NOT SEALED

Recommend qualified professional evaluate and repair.

Contact a qualified professional.

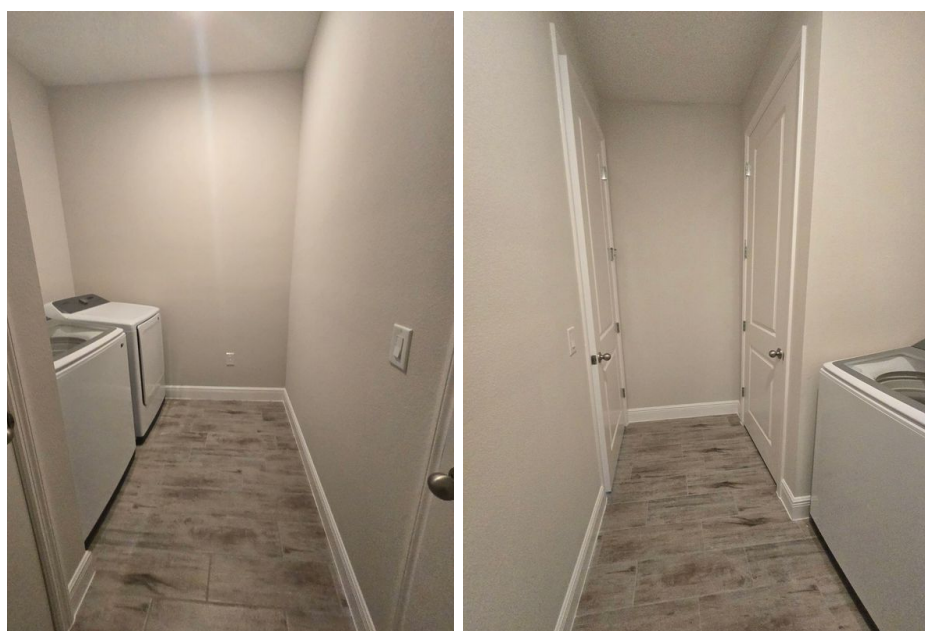
**General: Dryer Vent**

There is no visible dryer exhaust vent that discharges to the exterior of the property. Recommend a qualified contractor to evaluate and repair. Potential fire hazard.

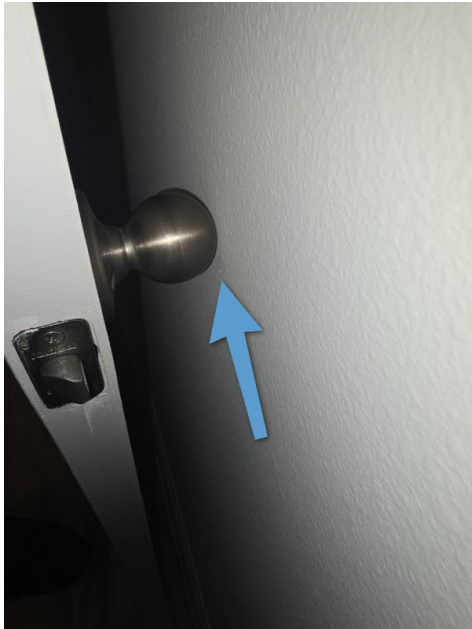
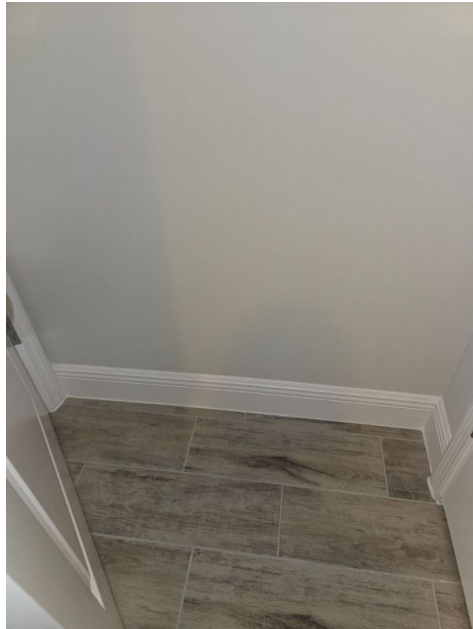
6.3.1 Walls

NO DOORSTOP TO PREVENT WALL DAMAGE.

Recommend qualified professional evaluate and repair.

Contact a qualified professional.

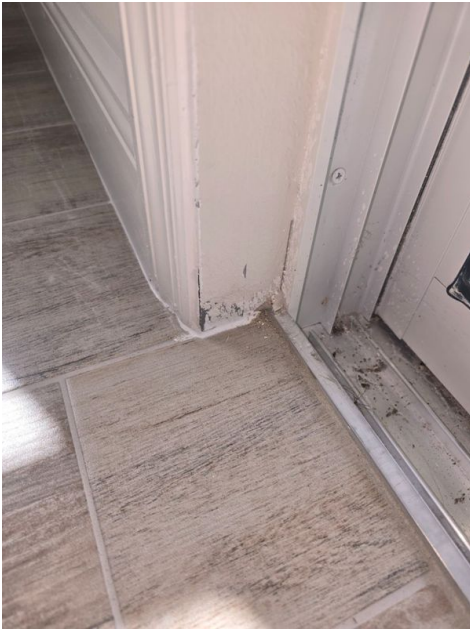
8.5.1 Walls

MINOR IMPERFECTIONS IN DRYWALL

Recommend qualified professional evaluate and repair

Contact a qualified professional.

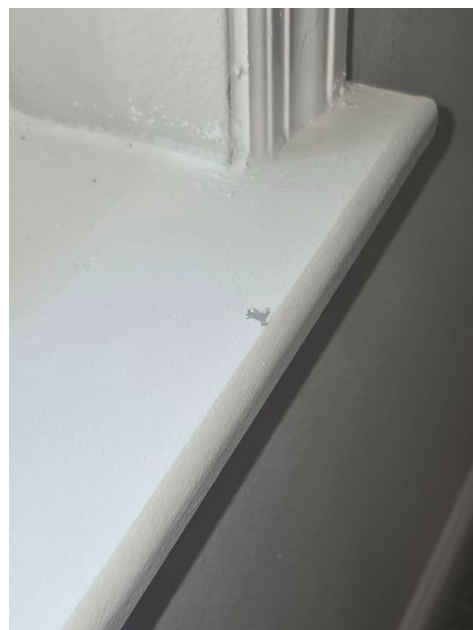
11.3.1 Windows

MINOR PAINTING FLAWS

Recommend qualified professional evaluate and repair.

Contact a qualified professional.

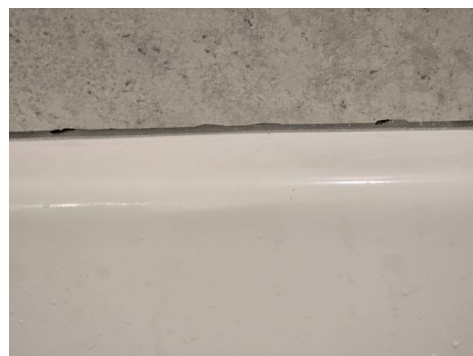
15.6.1 Shower/ Tub

CAULK/GROUT MAINTENANCE

Caulk/grout maintenance is needed around the tub/shower.

Contact a qualified professional.

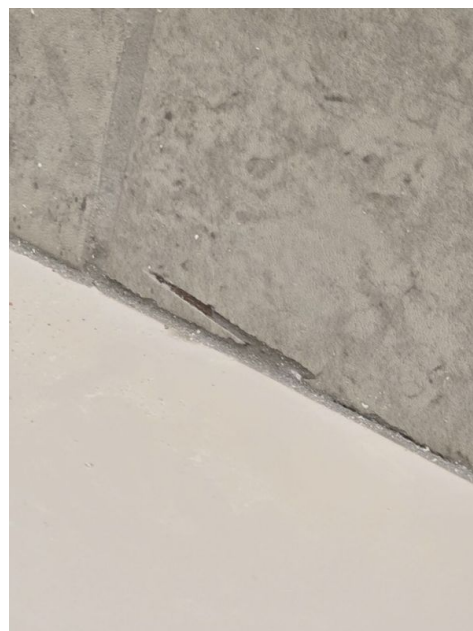
15.6.2 Shower/ Tub

MINOR TILE FLAW

Recommend qualified professional evaluate and repair

Contact a qualified professional.

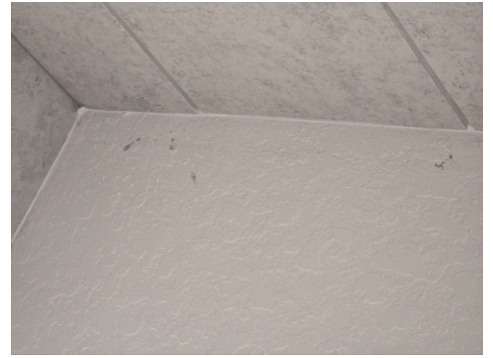
15.8.1 Ceilings

MINOR PAINTING FLAWS

Recommend qualified professional evaluate and repair

Contact a qualified professional.

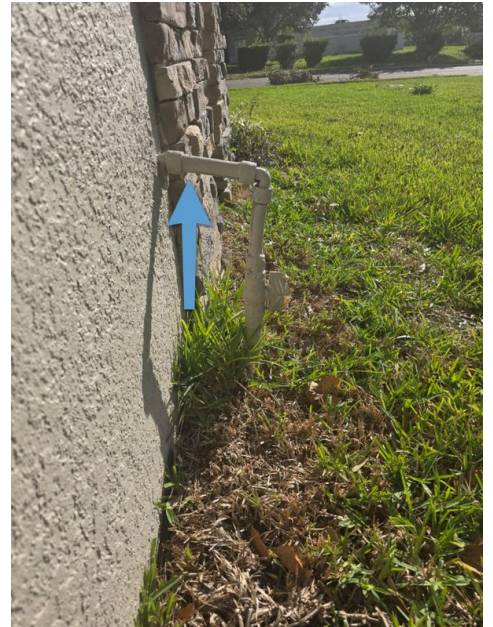
17.1.1 Water Supply & Distribution

WATER SUPPLY PIPING ENTERING THE BUILDING NOT FITTED CORRECTLY.

Recommend plumber evaluate and repair.

Contact a qualified plumbing contractor.

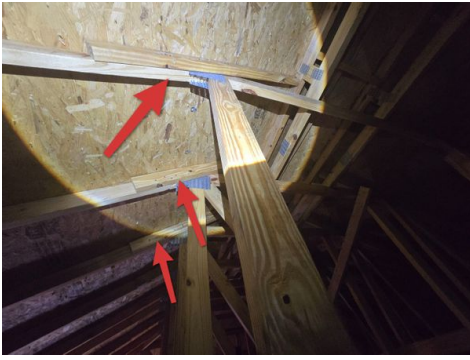
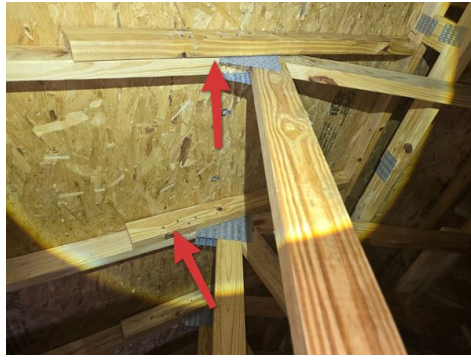
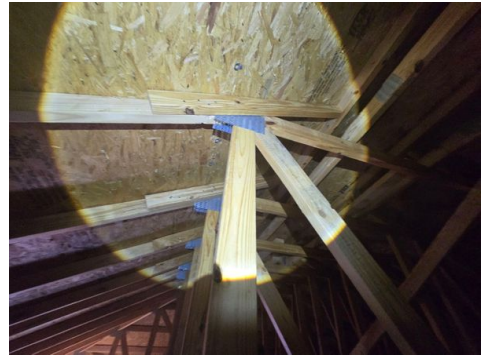
19.5.1 Roof Trusses

ROOF TRUSSES HAVE BEEN SPLICED AND EXTENDED.

Recommend asking builder for engineering approval.

Contact a qualified structural engineer.
